# Manhole Inspection Summary

Manhole # S35QQ1001MH

Insp Date: **3/20/07 1:08 PM**

**Location** Address: **340 WINSTON AVE**

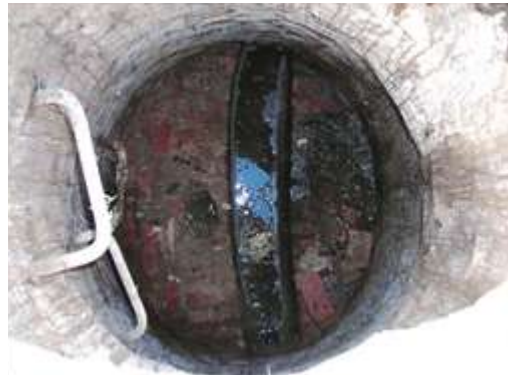
Top View

Corroded steps. Evidence of surcharge - Bench debris. Channel debris.

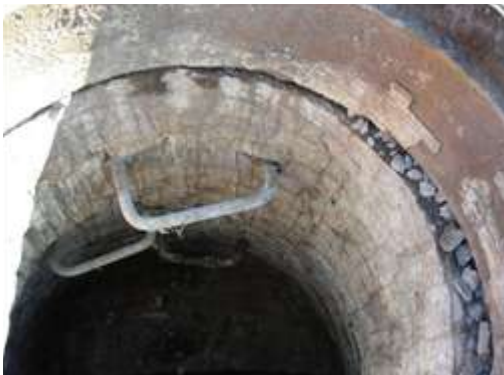
Defect

Frame leaks. Frame offset. Adjustment deterioration, loose brick and infiltration. Corbel and Barrel infiltration - other side.

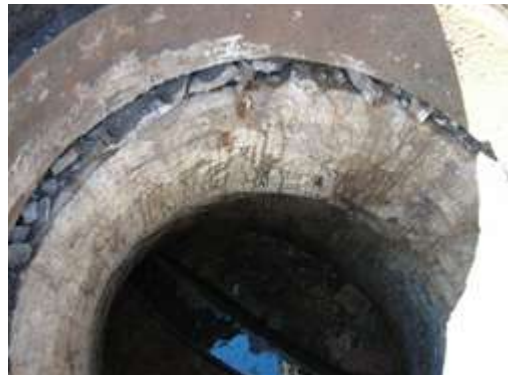
Defect

Frame leaks. Frame offset. Adjustment deterioration, loose brick and infiltration. Corbel and Barrel infiltration.

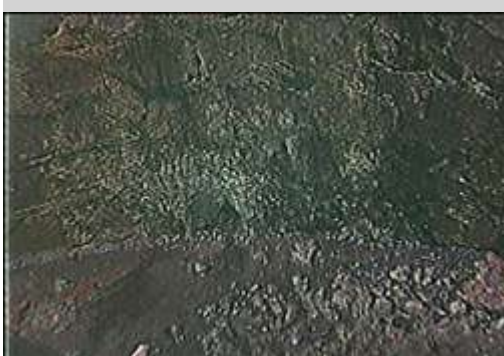
Defect

Barrel deterioration and infiltration.

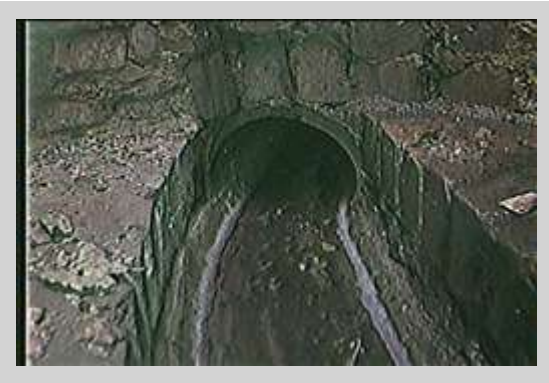
### 8 in. Circular Gravity Sewer Pipe Out @ 12 O'Clock

Barrel deterioration and infiltration. Channel deterioration.

Deposits: ☐ None ☒ **Mud** ☐ Sludge ☐ Debris ☐ Grease

Silt Depth: **0.5** (in.) Deposits Extent: **Light**

Infiltration: **Evidence** Pipe Seal Cond: **Unknown**

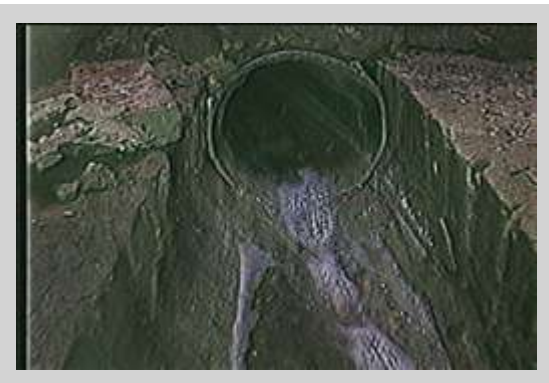
### 8 in. Circular Gravity Sewer Pipe In @ 5 O'Clock

Infiltration: **None** Pipe Seal Cond: **Cracked**
